PIC18F85J90 Family Silicon Errata and Data Sheet Clarification

The PIC18F85J90 family devices that you have received conform functionally to the current Device Data Sheet (DS39770C), except for the anomalies described in this document.

PIC18F85J90 FAMILY

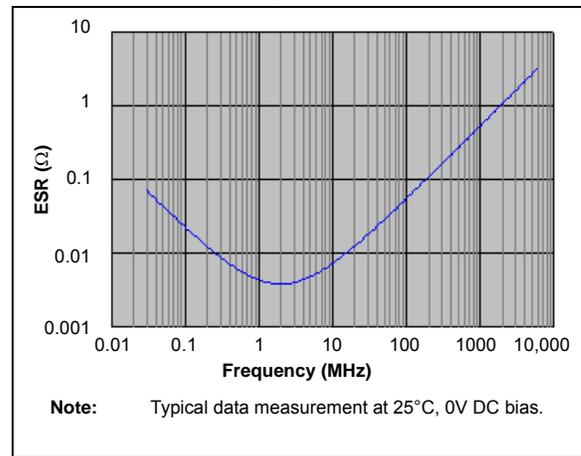
FIGURE 2-3 FREQUENCY vs. ESR PERFORMANCE FOR SUGGESTED VCAP

When the regulator is enabled, a low-ESR (< 5Ω) capacitor is required on the VCAP/VDDCORE pin to stabilize the voltage regulator output voltage. The VCAP/VDDCORE pin must not be connected to VDD and must use a capacitor of 10 μF connected to ground. The type can be ceramic or tantalum. Suitable examples of capacitors are shown in [Table 2-1](#). Capacitors with equivalent specification can be used.

Designers may use [Figure 2-3](#) to evaluate ESR equivalence of candidate devices.

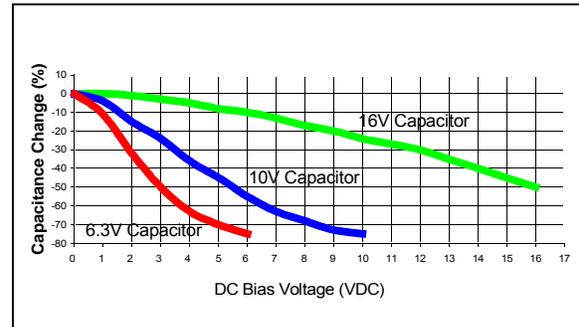
FIGURE 2-4 DC BIAS VOLTAGE vs. CAPACITANCE CHARACTERISTICS

In addition to temperature tolerance, the effective capacitance of large value ceramic capacitors can vary substantially, based on the amount of DC voltage applied to the capacitor. This effect can be very significant, but is often overlooked or is not always documented.

A typical DC bias voltage vs. capacitance graph for X7R type and Y5V type capacitors is shown in Figure 2-4.

When selecting a ceramic capacitor to be used with the VDDCORE voltage regulator, it is suggested to select a high-voltage rating, so that the operating voltage is a small percentage of the maximum rated capacitor voltage. For example, choose a ceramic capacitor rated at 16V for the 2.5V VDDCORE voltage. Suggested capacitors are shown in Table 2-1.
