**dsPIC33EVXXXGM00X/10X Family  
Silicon Errata and Data Sheet Clarification**

The dsPIC33EVXXXGM00X/10X family devices that you have received conform functionally to the current Device Data Sheet (DS70005144E), except for the anomalies described in this document.

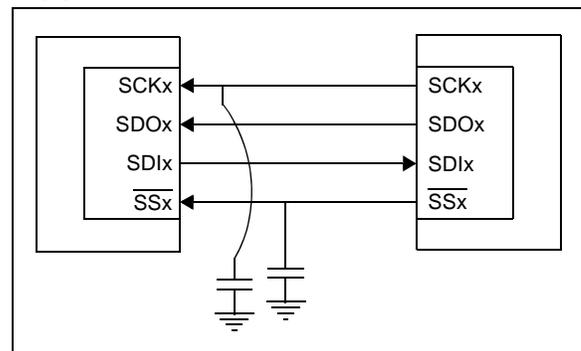
FIGURE 1:

When the SPIx module is configured in SPIx Slave mode (MSTEN bit (`SPIxCON1<5>`) = 0), the frame slave (FRMEN bit (`SPIxCON2<15>`) = 1) and the SPIFSD bit (`SPIxCON2<14>` = 1), in Standard Buffer mode with the Clock Polarity Select bit, `CKP` = 0, the data is not transmitted in both 8-bit and 16-bit mode, but the data is being received correctly.

Adding a capacitance on the signal, as shown in [Figure 1](#), will help the data to be received properly.

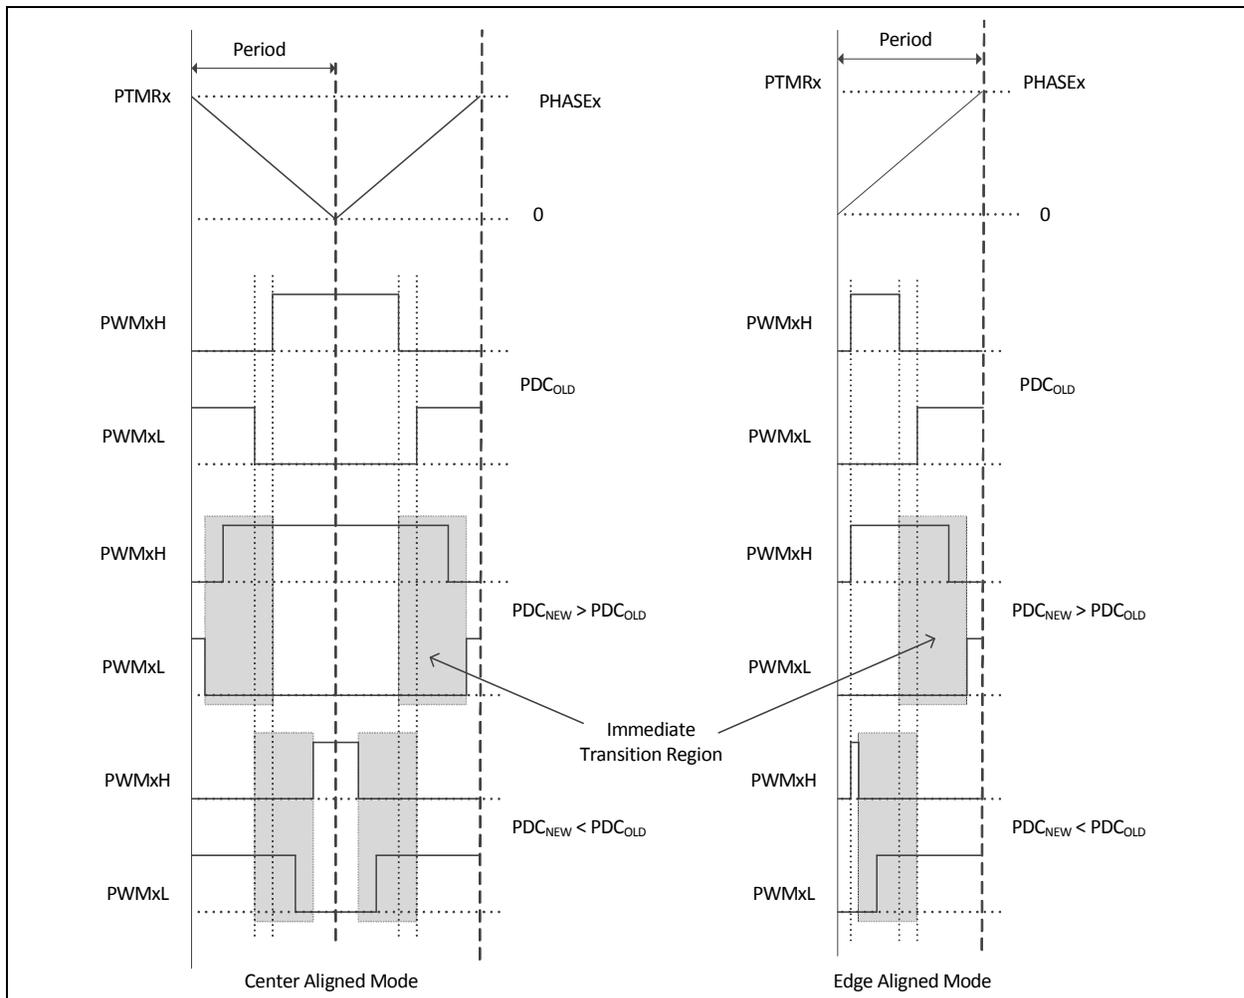
**FIGURE 2: TIMING DIAGRAMS FOR CENTER-ALIGNED AND EDGE-ALIGNED MODES**

The PWM generator may not assert dead time on the edges of transitions. This has been observed when all of the following conditions are present:

time base, will determine if the PWMxH and PWMxL outputs make an immediate transition. PWMxH and PWMxL outputs make an immediate transition if the Duty Cycle register is written with a new value, PDC<sub>NEW</sub>, at a point of time when the PWM time base is counting a value that is in between PDC<sub>NEW</sub> and PDC<sub>OLD</sub>. Additionally, writing to the Duty Cycle register, close to the instant of time where dead time is being applied, may result in a reduced dead time effective on the PWMxH and PWMxL transition edges.

In [Figure 2](#), if the duty cycle write occurred in the shaded box, then PWMxH and PWMxL will make an immediate transition without dead time.

However, in most applications, the duty cycle update timing can be controlled using the TRIGx trigger or Special Event Trigger, such that the above mentioned conditions are avoided altogether.

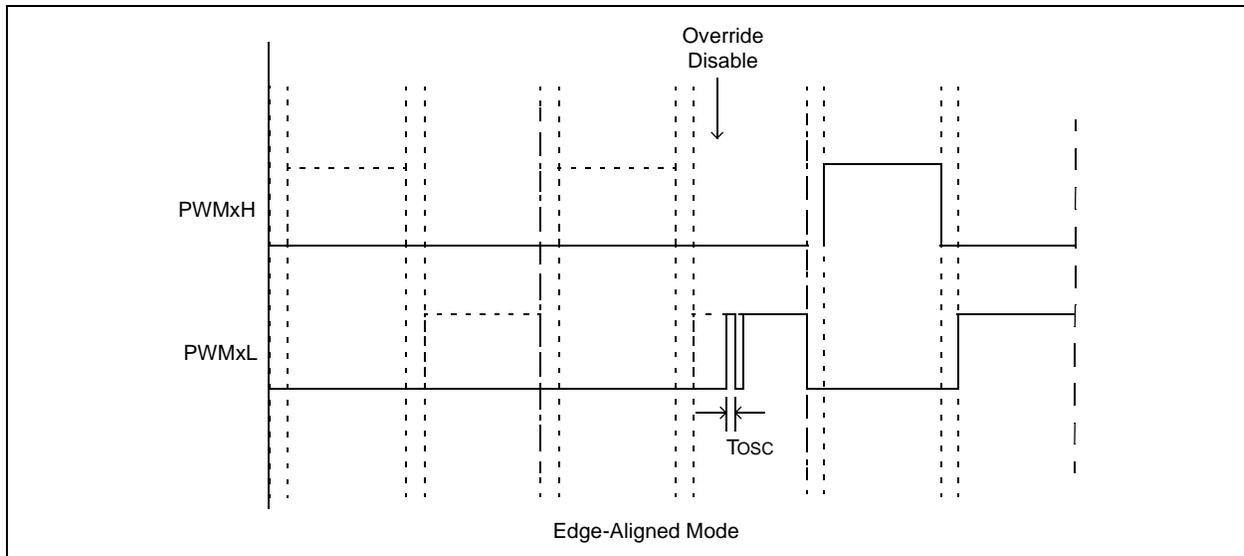
**FIGURE 3: ILLUSTRATION OF 1 TOSC GLITCH WHEN PWM OVERRIDE IS TURNED OFF**

In Complementary mode after the PWM module is enabled (PTEN = 1), if the PWM override is turned off, a 1 TOSC glitch will be present on the rising edge of either the PWMxH or PWMxL pins, whichever occurs first, as shown in Figure 3.

The glitch will be present on PWMxH/PWMxL every time the override state is changed from override enabled to override disabled. The width of this glitch is equal to 1 TOSC when PCLKDIV<2:0> (PTCON2<2:0>) = 000. Increasing the PWMx input clock prescaler setting will increase the width of the glitch accordingly.

Since the width of the glitch is just 1 TOSC at higher values of FOSC, the glitch may not be visible on the PWMxH/PWMxL pins due to pin and PCB trace capacitances.

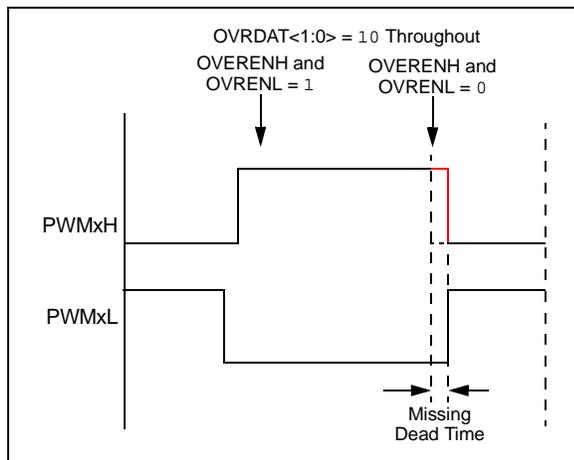
FIGURE 4:

In Complementary Output mode, the expected dead time between transitions of the PWMxH and PWMxL outputs may not be asserted when the following occurs:

- Output override synchronization is configured to occur on the CPU clock boundary (IOCONx<0> = 0);
- Both PWMxH and PWMxL overrides are enabled prior to the event (OVRENH and OVRENL are both '1'), and
- Both overrides are disabled (OVRENH and OVRENL are both '0') at the instant the dead time should be asserted (Figure 4). This has been observed in both Center-Aligned and Edge-Aligned modes.

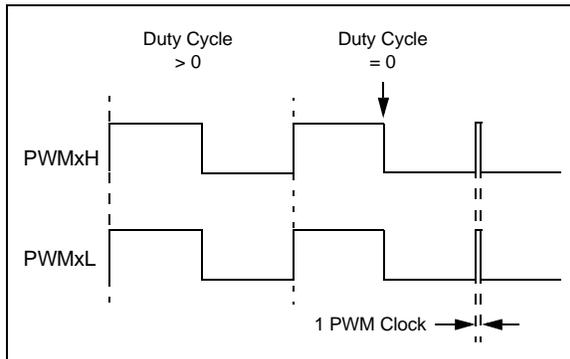
FIGURE 5:

In the Redundant Output mode (IOCONx<11:10> = 10) and Push-Pull Output mode (IOCONx<11:10> = 01) with Immediate Update disabled (PWMCONx<0> = 0), when the Duty Cycle register is updated from a non-zero value to zero, a glitch pulse of a width equal to 1 PWM clock will appear at the next PWM period boundary, as shown in Figure 5, for the Redundant Output mode. Here, the Duty Cycle register refers to the PDCx register if PWMCONx<8> = 0 or the MDC register if PWMCONx<8> = 1.

If the application requires a zero duty cycle output, there are two possible work around methods:

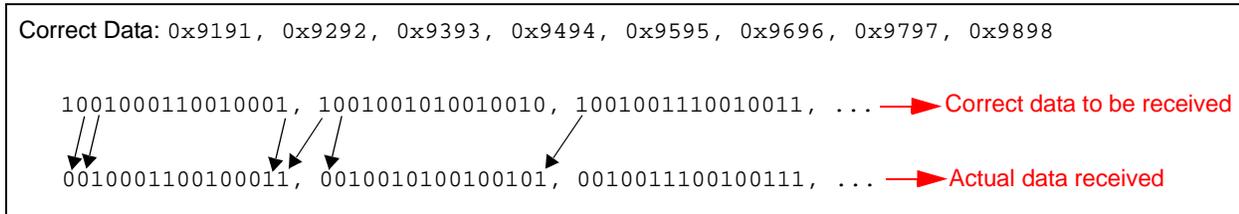
**FIGURE 6:**

Received data of the SPI is sampled one clock cycle late for the following conditions:

For example, the correct data that should be received is 0x9191, 0x9292, 0x9393, 0x9494, 0x9595, 0x9696, 0x9797, 0x9898, but the actual data received is 0x2323, 0x2525, 0x2727, 0x2929, 0x2B2B, 0x2D2D, 0x2F2F, 0x3130 (Figure 6).
