dsPIC33FJ06GS101/X02 and dsPIC33FJ16GSX02/X04

dsPIC33FJ06GS101/X02 and dsPIC33FJ16GSX02/X04 Family Silicon Errata and Data Sheet Clarification

The dsPIC33FJ06GS101/X02 and dsPIC33FJ16GSX02/X04 family devices that you have received conform functionally to the current Device Data Sheet (DS70000318G), except for the anomalies described in this document.

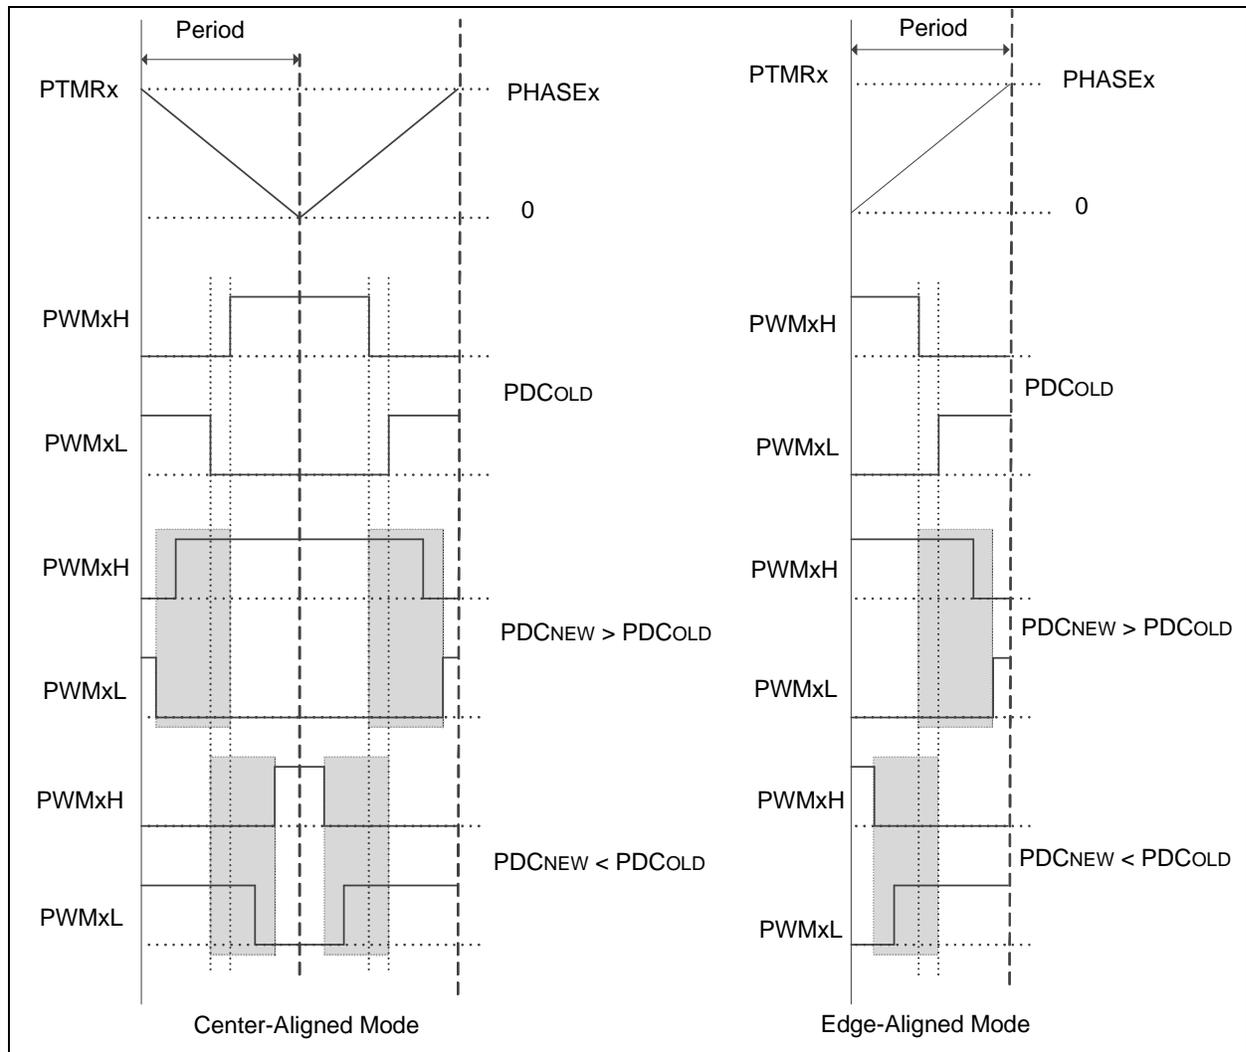
FIGURE 1: TIMING DIAGRAMS FOR CENTER-ALIGNED AND EDGE-ALIGNED MODES

The PWMx generator may not assert dead time on the edges of transitions. This has been observed when all of the following conditions are present:

None. However, in most applications, the duty cycle update timing can be controlled using the TRIGx trigger or Special Event Trigger, such that the above mentioned conditions are avoided altogether.

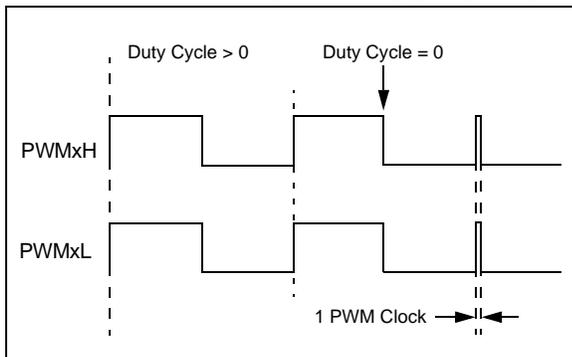
FIGURE 2: ISSUE EXAMPLE FOR REDUNDANT OUTPUT MODE

In Redundant Output mode (IOCONx<11:10> = 01) and Push-Pull Output mode (IOCONx<11:10> = 10), with the Immediate Update disabled (PWMCONx<0> = 0), when the Duty Cycle register is updated from a non-zero value to zero, a glitch pulse of a width equal to 1 PWM clock will appear at the next PWM period boundary, as shown in Figure 2 (for the Redundant Output mode). The Duty Cycle register refers to the PDCx register if PWMCONx<8> = 0 or the MDC register if PWMCONx<8> = 1.

If the application requires a zero duty cycle output, there are two possible work around methods:
