**MP3**  
**Microcontrollers**

**AT85C51SND3Bx**

**Errata Sheet**

7656A-MP3-04/07

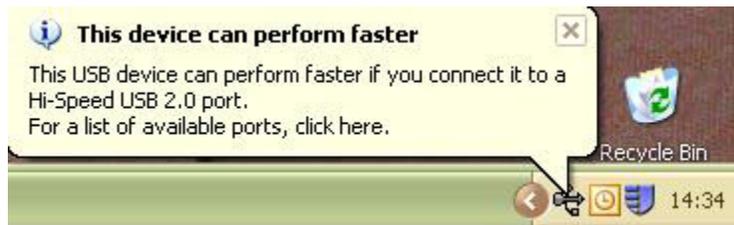
## 6. ISP – ISP USB enumeration on Windows™ XP

When connecting the device to windows XP, an informational pop-up is opened near the status bar:

This is a windows dummy message since ISP is done in full speed mode.

None. Do not take care of this pop-up.
