ES_LPC4350/30/20/10 Rev A

Errata sheet LPC4350, LPC4330, LPC4320, LPC4310 Rev A

Rev. 4 — 25 January 2013

Errata sheet

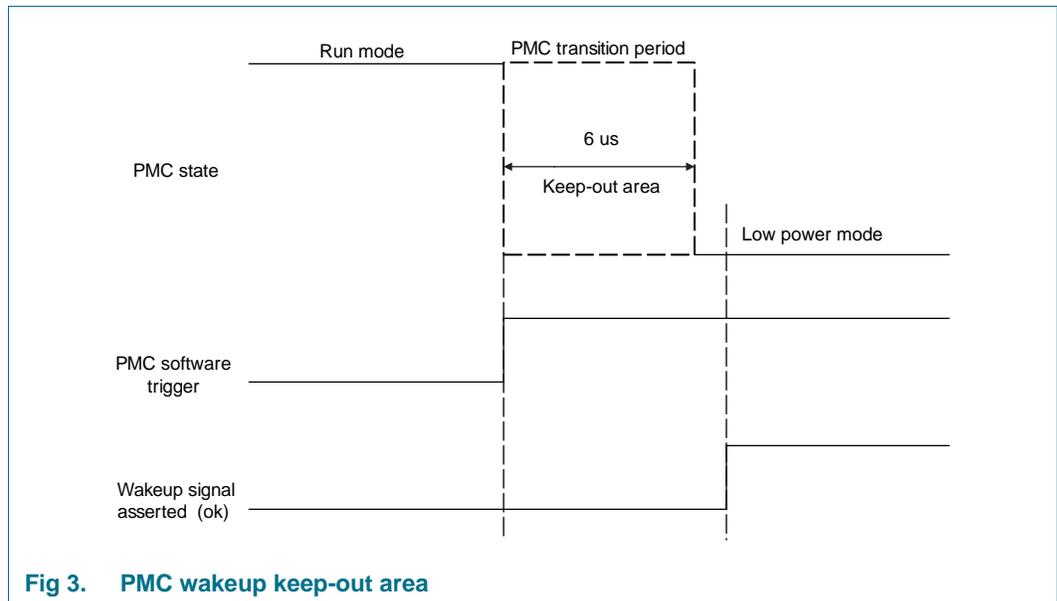
Fig 3. PMC wakeup keep-out area

Problem:

When the chip is in a transition from active to Deep Sleep, Power Down, or Deep Power Down, wakeup events are not captured and they will block further wakeup events from propagating. The time window for this transition is 6 uS and is not affected by the chip clock speed. After a wakeup event is received during the PMC transition, the chip can only recover by using an external hardware reset or by cycling power.

Work-around:

Make sure that a wakeup signal is not received during the Deep Sleep, Power Down, or Deep Power Down transition period. An example circuit to work around this could include an external 6 uS one shot which could be triggered via software using a GPIO line when entering Deep Sleep, Power Down, or Deep Power Down mode. The one-shot's output could be used to gate the wakeup signal(s) to prevent receiving a wakeup signal during the PMC transition period. Depending on the system design, it may also be needed to latch the wakeup signal(s) so that they will still be present after the one-shot's 6 uS timeout.
