# MICROCHIP PIC18F2420/2520/4420/4520

## PIC18F2420/2520/4420/4520 Rev. B2 Silicon Errata

The PIC18F2420/2520/4420/4520 Rev. B2 parts you have received conform functionally to the Device Data Sheet (DS39631C), except for the anomalies described below. Any Data Sheet Clarification issues related to the PIC18F2420/2520/4420/4520 will be reported in a separate Data Sheet errata. Please check the Microchip web site for any existing issues.

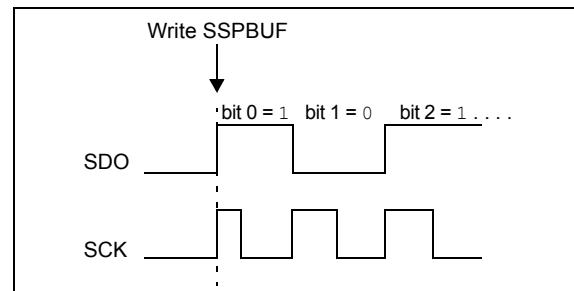
**FIGURE 1: SCK PULSE VARIATION USING TIMER2/2**

When the SPI is using Timer2/2 as the clock source, a shorter than expected SCK pulse may occur on the first bit of the transmitted/received data (Figure 1).

To avoid producing the short pulse, turn off Timer2 and clear the TMR2 register, load the SSPBUF with the data to transmit and then turn Timer2 back on. Refer to Example 2 for sample code.

```
LOOP BTFSS SSPSTAT, BF      ;Data received?  
                                ;(Xmit complete?)  
    BRA    LOOP                ;No  
    MOVF   SSPBUF, W           ;W = SSPBUF  
    MOVWF  RXDATA              ;Save in user RAM  
    MOVF   TXDATA, W           ;W = TXDATA  
    BCF    T2CON, TMR2ON       ;Timer2 off  
    CLRF   TMR2                ;Clear Timer2  
    MOVWF  SSPBUF              ;Xmit New data  
    BSF    T2CON, TMR2ON       ;Timer2 on
```
