PIC16(L)F1826/1827 Family Silicon Errata and Data Sheet Clarification

The PIC16(L)F1826/1827 family devices that you have received conform functionally to the current Device Data Sheet (DS41391D), except for the anomalies described in this document.

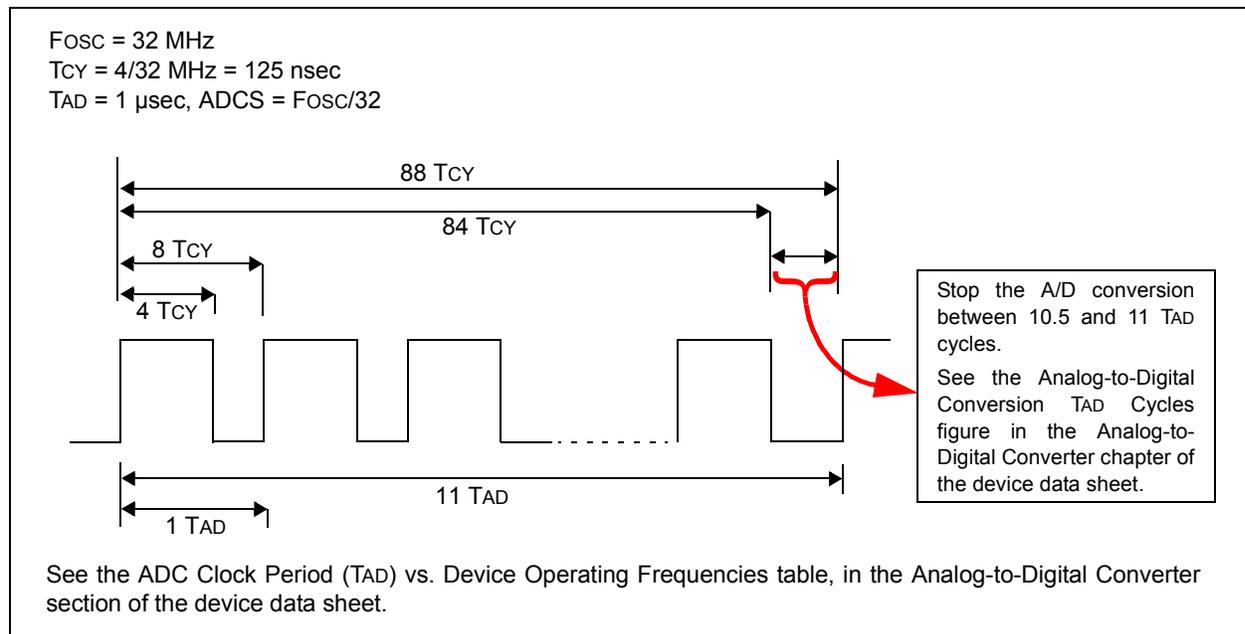
FIGURE 1: INSTRUCTION CYCLE DELAY CALCULATION EXAMPLE

An ADC conversion may not complete under these conditions:

1. When F_{OSC} is greater than 8 MHz and it is the clock source used for the ADC converter.
2. The ADC is operating from its dedicated internal FRC oscillator and the device is not in Sleep mode (any F_{OSC} frequency).

When this occurs, the ADC Interrupt Flag (ADIF) does not get set, the $\overline{GO/DONE}$ bit does not get cleared, and the conversion result does not get loaded into the ADRESH and ADRESL result registers.

In Figure 1, 88 instruction cycles (T_{CY}) will be required to complete the full conversion. Each TAD cycle consists of eight T_{CY} periods. A fixed delay is provided to stop the A/D conversion after 86 instruction cycles and terminate the conversion at the correct time as shown in the figure above.

Method 3: This method is provided if the application cannot use Sleep mode and requires continuous operation at frequencies above 8 MHz. This method requires early termination of an ADC conversion. Provide a fixed time delay in software to stop the A-to-D conversion manually, after all ten bits are converted, but before the conversion would complete automatically. The conversion is stopped by clearing the $\overline{GO/DONE}$ bit in software. The $\overline{GO/DONE}$ bit must be cleared during the last $\frac{1}{2}$ TAD cycle, before the conversion would have completed automatically. Refer to Figure 1 for details.

Note: The exact delay time will depend on the TAD divisor (ADCS) selection. The Tcy counts shown in the timing diagram above apply to this example only. Refer to [Table 3](#) for the required delay counts for other configurations.

```
BSF    ADCON0, ADGO    ; Start ADC conversion
                        ; Provide 86
                        ; instruction cycle
                        ; delay here
BCF    ADCON0, ADGO    ; Terminate the
                        ; conversion manually
MOVF   ADRESH, W       ; Read conversion
                        ; result
```
