PIC18F6310/6410/8310/8410 Rev. B3 Silicon Errata

The PIC18F6310/6410/8310/8410 Rev. B3 parts you have received conform functionally to the Device Data Sheet (DS39635C), except for the anomalies described below. Any Data Sheet Clarification issues related to the PIC18F6310/6410/8310/8410 will be reported in a separate Data Sheet errata. Please check the Microchip web site for any existing issues.

The following silicon errata apply only to PIC18F6310/6410/8310/8410 devices with these Device/Revision IDs:

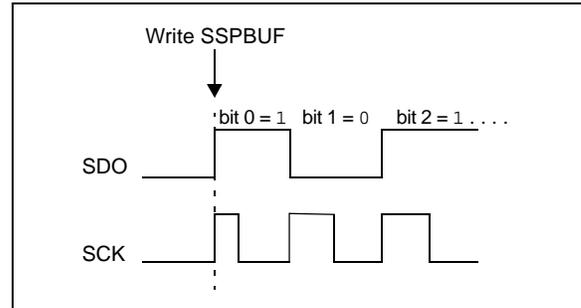
FIGURE 1: SCK PULSE VARIATION USING TIMER2/2

When the SPI is using Timer2/2 as the clock source, a shorter than expected SCK pulse may occur on the first bit of the transmitted/received data (Figure 1).

To avoid producing the short pulse, turn off Timer2 and clear the TMR2 register, load the SSPBUF with the data to transmit and then turn Timer2 back on. Refer to Example 4 for sample code.
