## PIC16(L)F1782/1783 Family Silicon Errata and Data Sheet Clarification

The PIC16(L)F1782/1783 family devices that you have received conform functionally to the current Device Data Sheet (DS41579D), except for the anomalies described in this document.

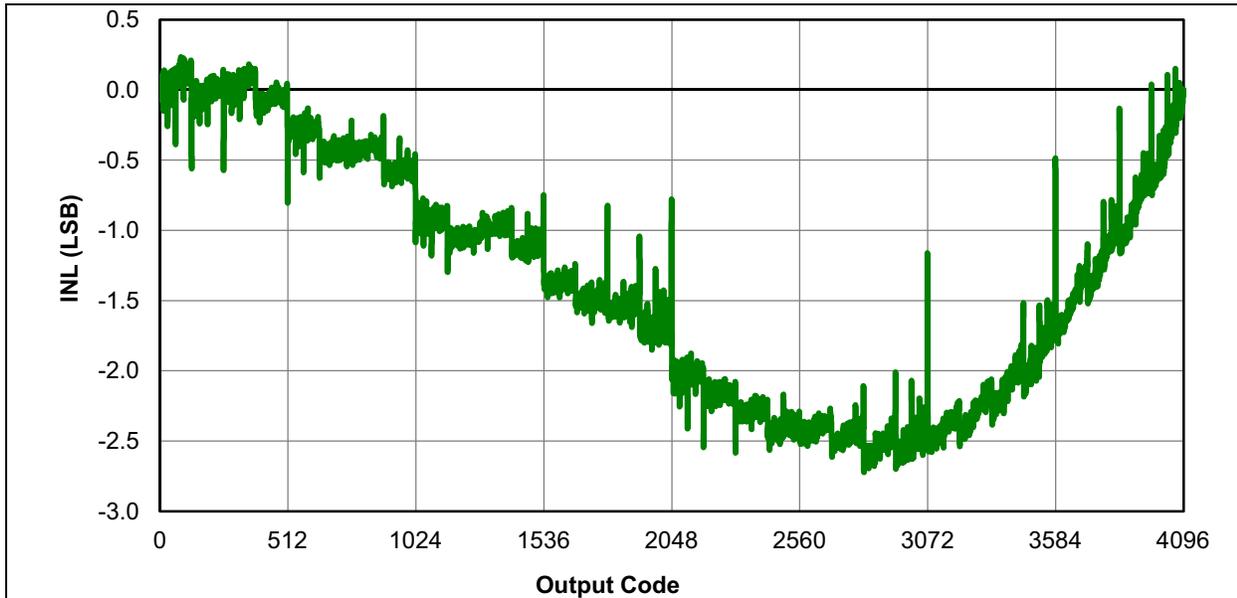
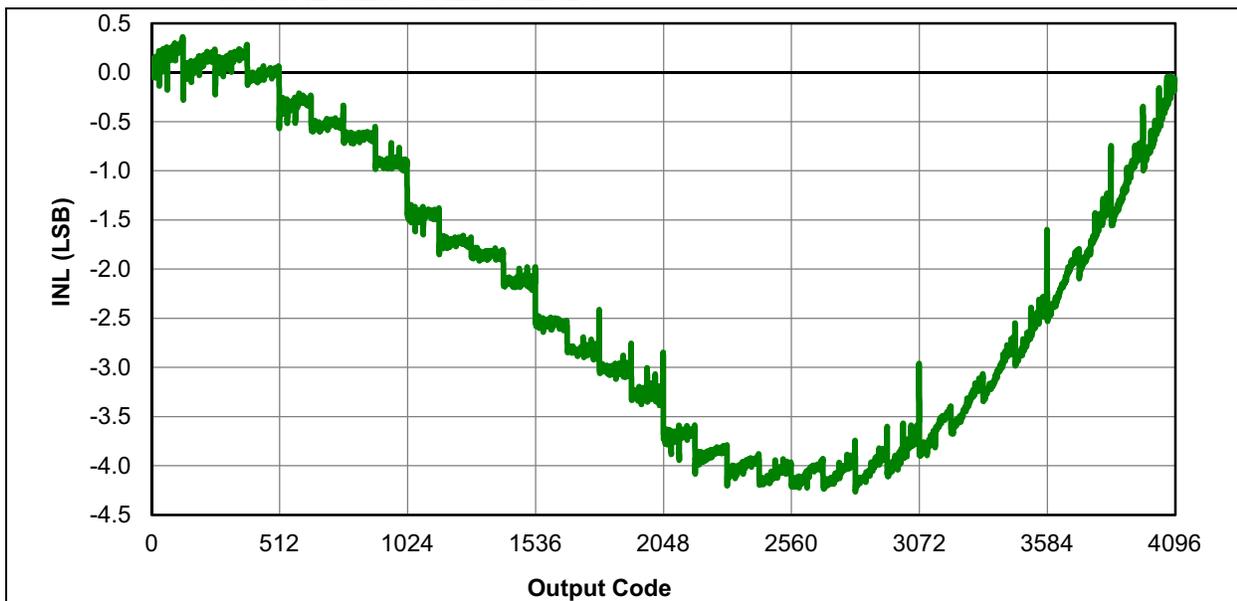
## 1.3 ADC INL (12-bit mode)

The ADC linearity is  $\pm 4$  LSB for the 12-bit mode. Below are typical INL graphs in 12-bit mode (See [Figure 1](#) and [Figure 2](#)).

**FIGURE 1: ADC 12-BIT MODE, SINGLE-ENDED INL,  $V_{DD} = 3.0V$ ,  $T_{AD} = 4 \mu s$ ,  $25^{\circ}C$ , TYPICAL MEASURED VALUES**

**FIGURE 2: ADC 12-BIT MODE, SINGLE-ENDED INL,  $V_{DD} = 5.5V$ ,  $T_{AD} = 4 \mu s$ ,  $25^{\circ}C$ , TYPICAL MEASURED VALUES**

### Work around

None.

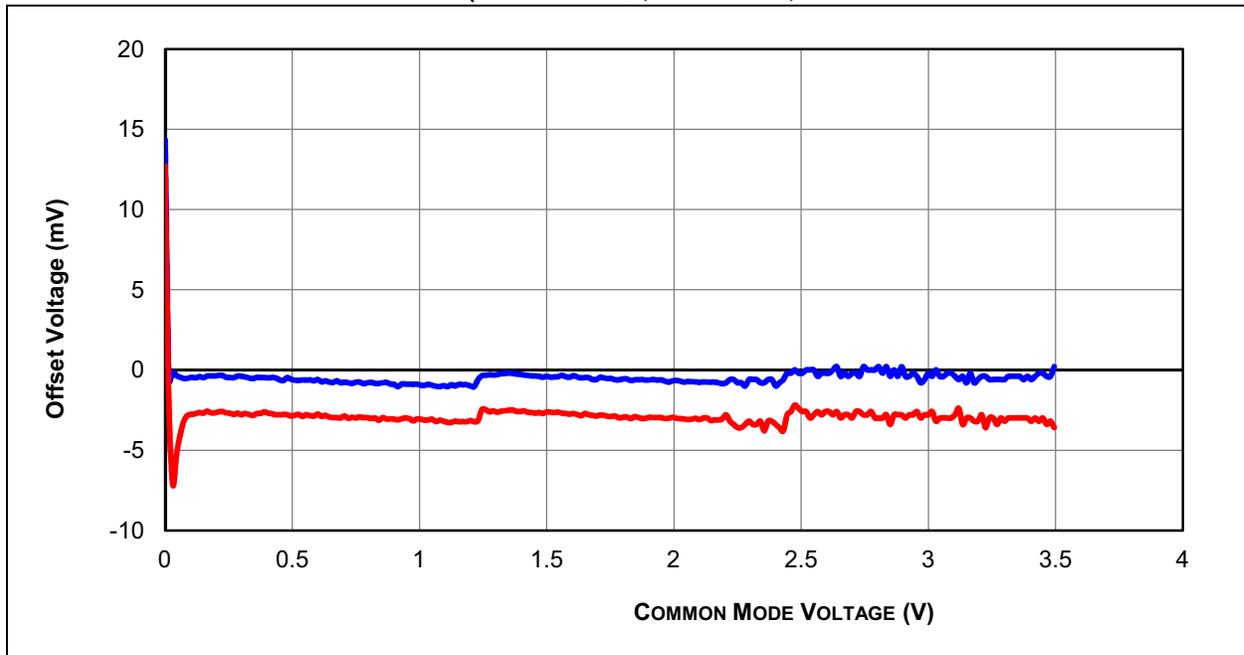
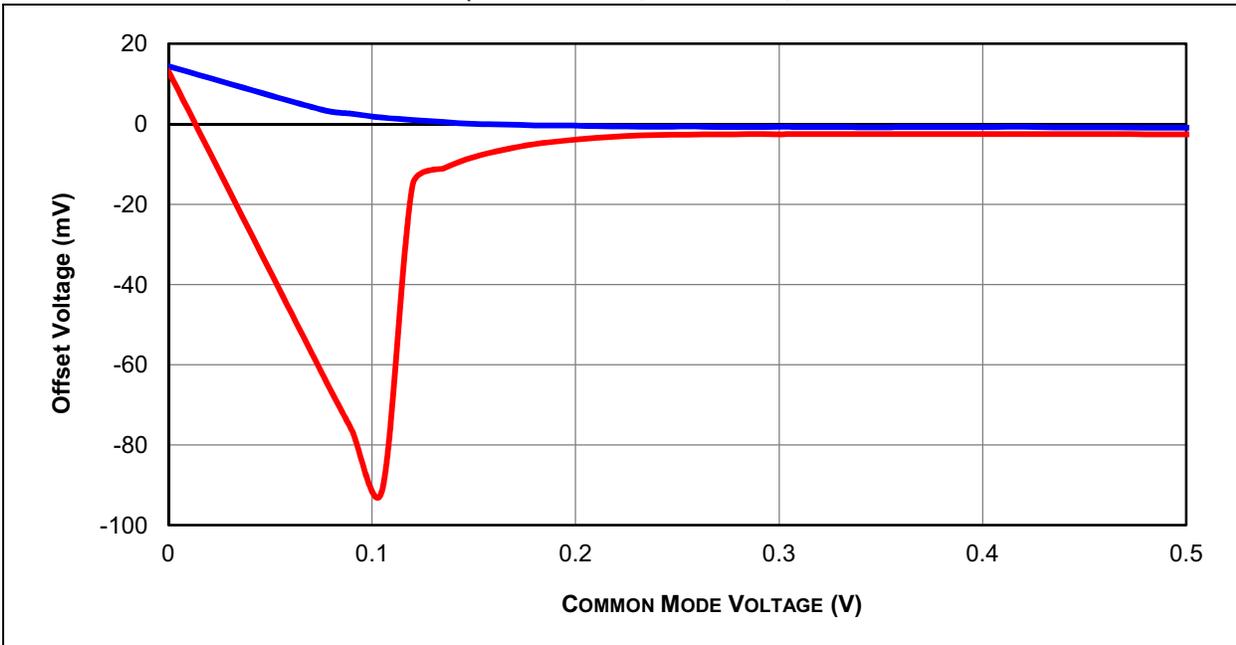
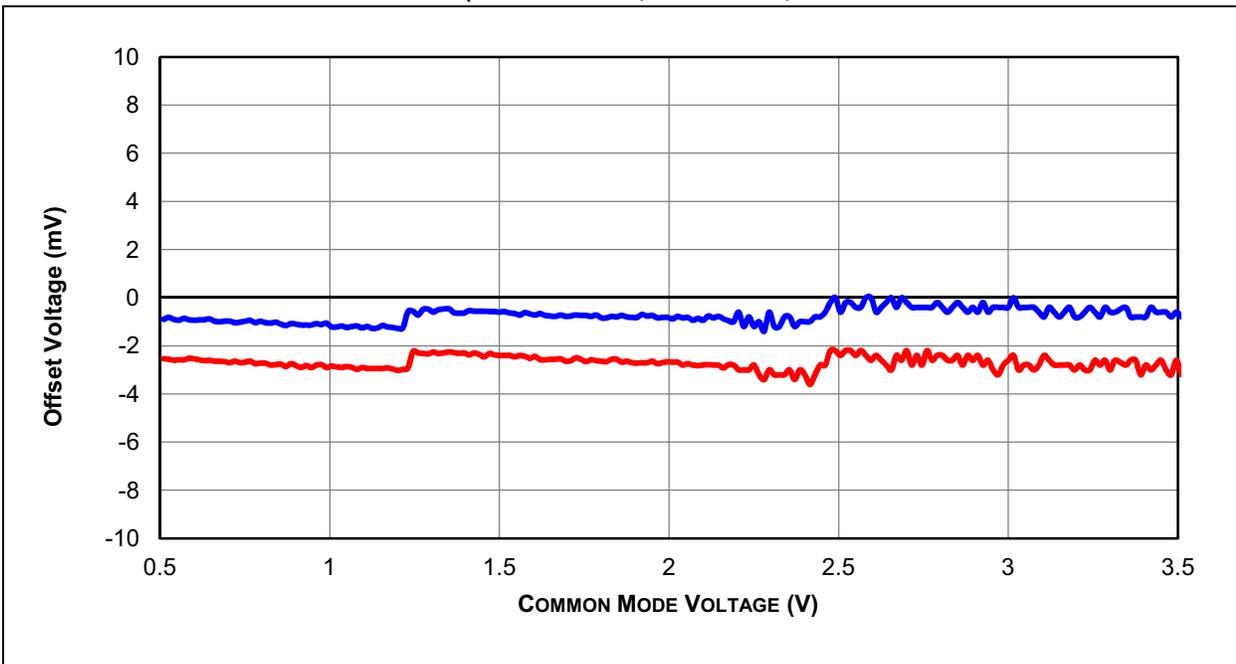
### 2.1 Offset at Low Common Mode

The op amp offset at Common mode input voltages below 200 mV increases with respect to temperature. Below are typical graphs showing the increase in offset (See [Figure 3](#), [Figure 4](#) and [Figure 5](#)).

**FIGURE 3: OP AMP TYPICAL OFFSET VOLTAGE AT 25°C, HIGH GBWP MODE (OPAxSP = 1), VDD = 3.6V, 0V ≤ CMV ≤ 5.5V**

**FIGURE 4: OP AMP TYPICAL OFFSET VOLTAGE AT LOW VCM, 85°C, HIGH GBWP MODE (OPAxSP = 1), V<sub>DD</sub> = 3.6V, 0V ≤ CMV ≤ 0.5V**

**FIGURE 5: OP AMP TYPICAL OFFSET VOLTAGE AT 85°C, HIGH GBWP MODE (OPAxSP = 1), V<sub>DD</sub> = 3.6V, 0.5V ≤ CMV ≤ 3.5V**

### Work around

None.

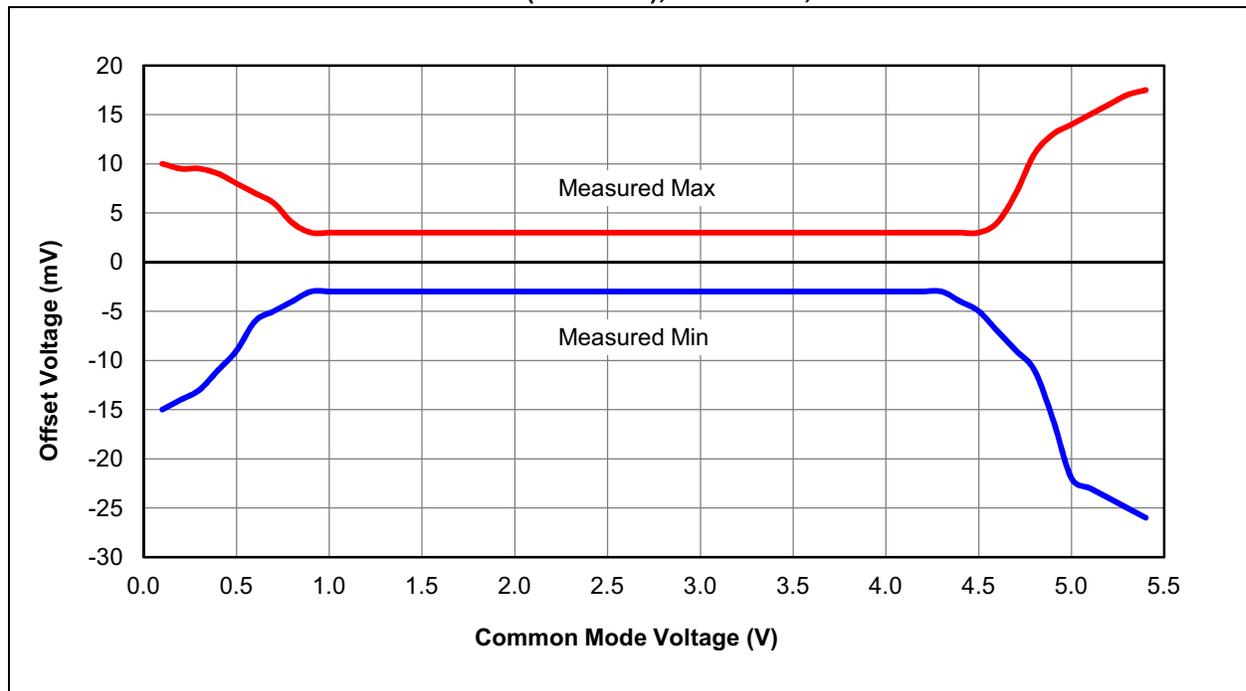
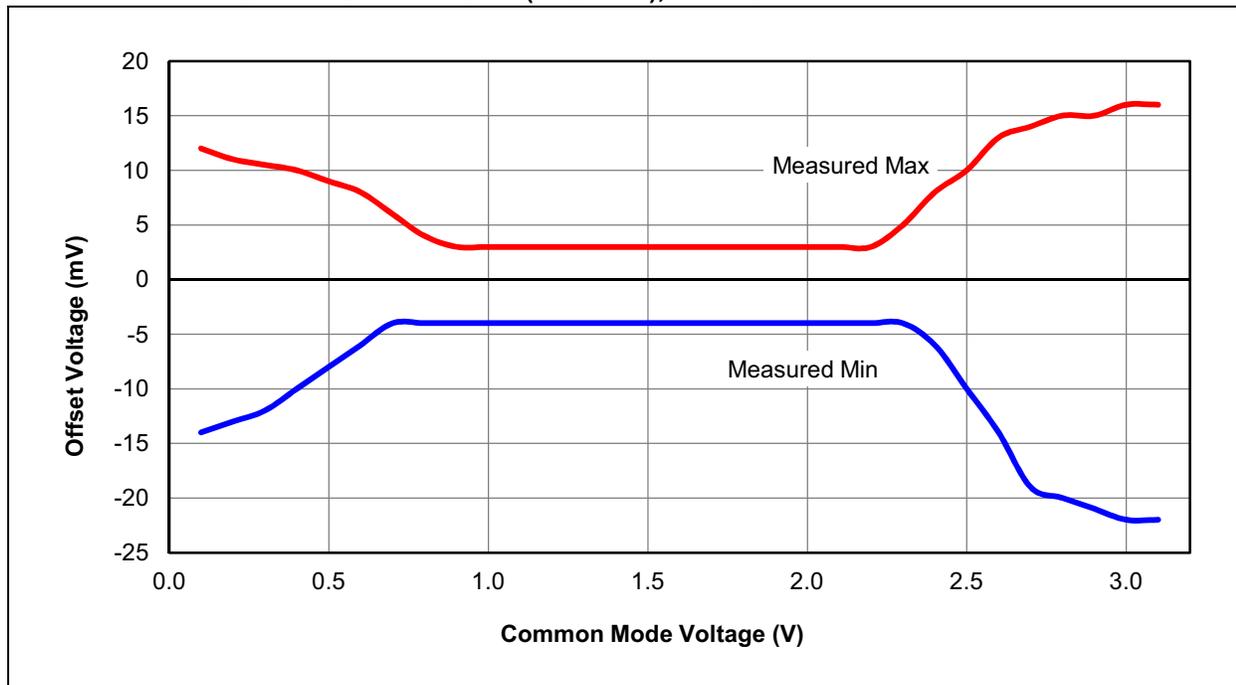
#### 3.2 Typical Offset Performance

CMRR performance for the range of  $V_{SS} + 1V$  to  $V_{DD} - 1V$  is better than specified in the data sheet.

**FIGURE 6: COMPARATOR INPUT OFFSET, TYPICAL MEASURED VALUES, NORMAL SPEED MODE (CxSP = 1),  $V_{DD} = 5.5V$ , PIC16F1782/1783 ONLY**

**FIGURE 7: COMPARATOR INPUT OFFSET, TYPICAL MEASURED VALUES, NORMAL SPEED MODE (CxSP = 1), VDD = 3.2V**

##### Work around

See [Figure 6](#) and [Figure 7](#).
